# Technical Memorandum

**Subject:** Reestablishment of Stearns County Ditch 4  
Public Drainage System Records

**Date:** January 17, 2019  
**Revised 3-18-2019**

**Project:** 6364-008

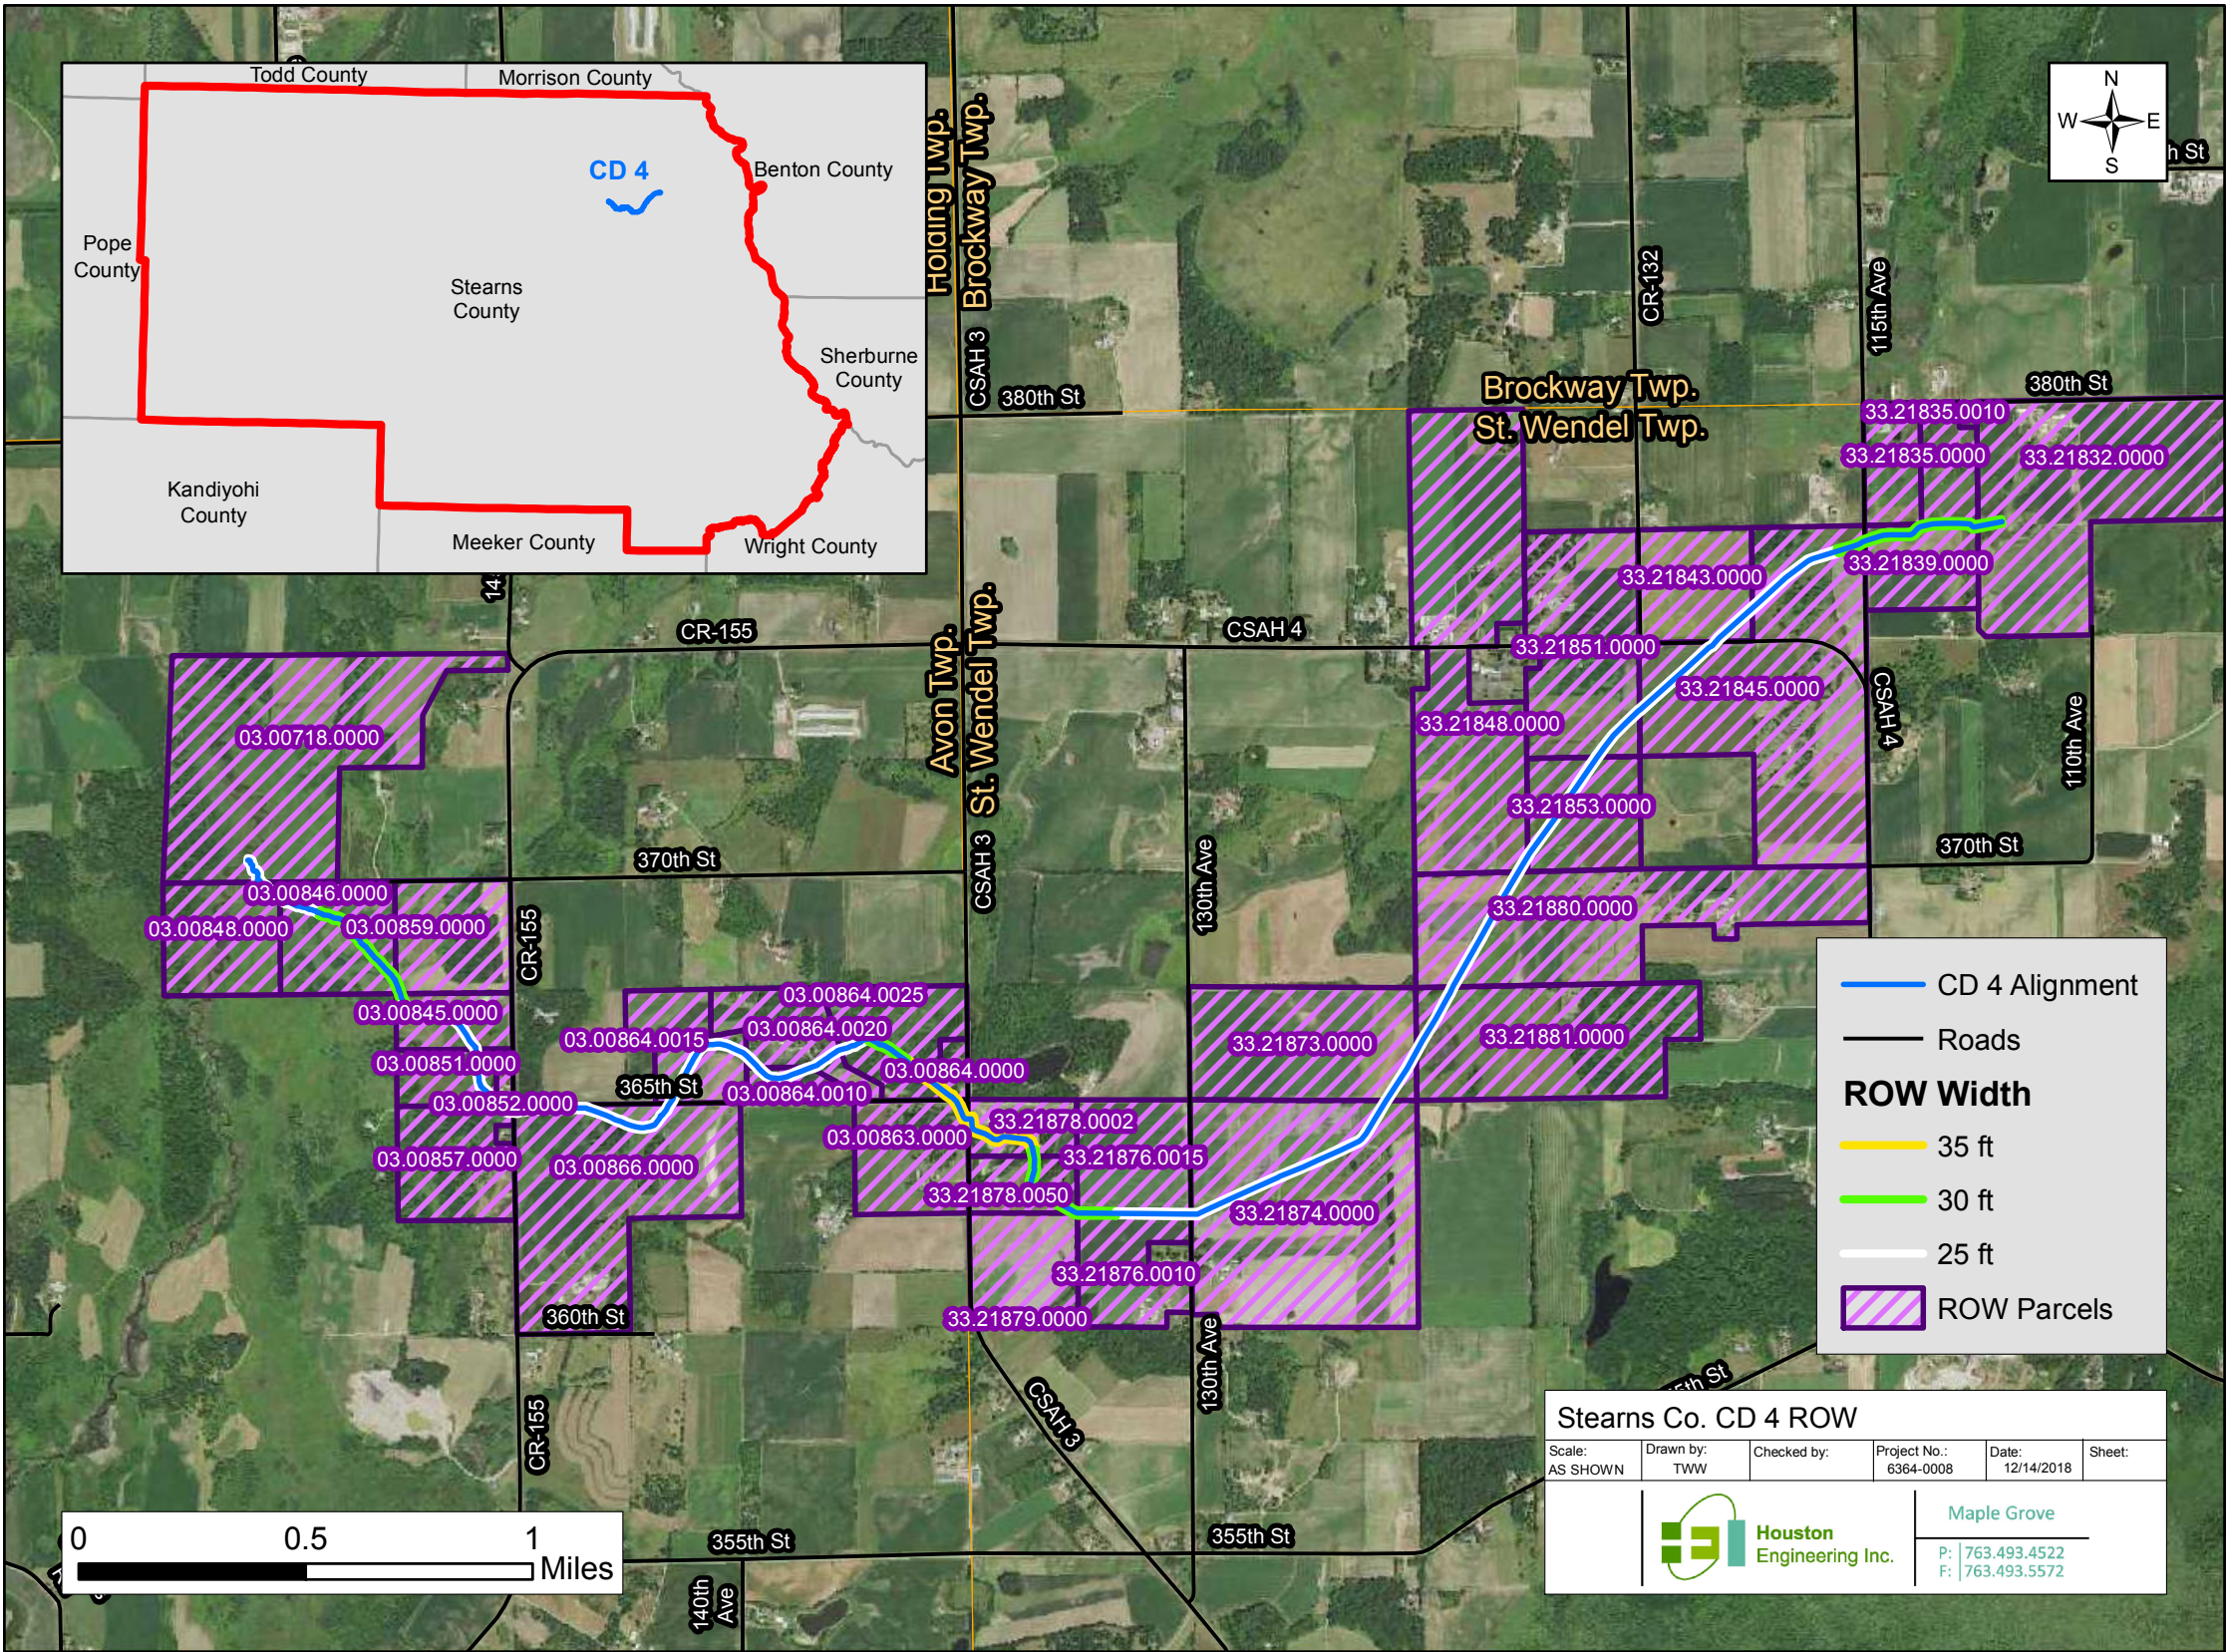
**Stearns Co. CD 4 ROW**

Proceedings for the original establishment of the drainage system awarded damages for the areas physically occupied by the drainage system along with an easement for the area required for construction activities such as land clearing and spoil disposal. This combination of areas constitutes the right-of-way for the drainage system and is often described as the area reasonably necessary for the drainage authority to perform its repair, maintenance, inspection obligations, along with an area of reasonable set-back to protect the drainage system. The right of way required was estimated by computing the approximate geometry of the spoil piles and the width needed for continued maintenance. The majority of the right of way is 25 feet from the top of bank of the ditch. However, there are a few locations where the ditch right of way extends to 30 feet from the top of bank, such as stations 5+00 to 20+00, 140+00 to 155+00, 175+00 to 180+00, and 250+00 to 265+00. In addition,

the ditch right of way extends to 35 feet from the top of bank from stations 155+00 to 175+00. See **Figure 2** for right of way widths and locations.

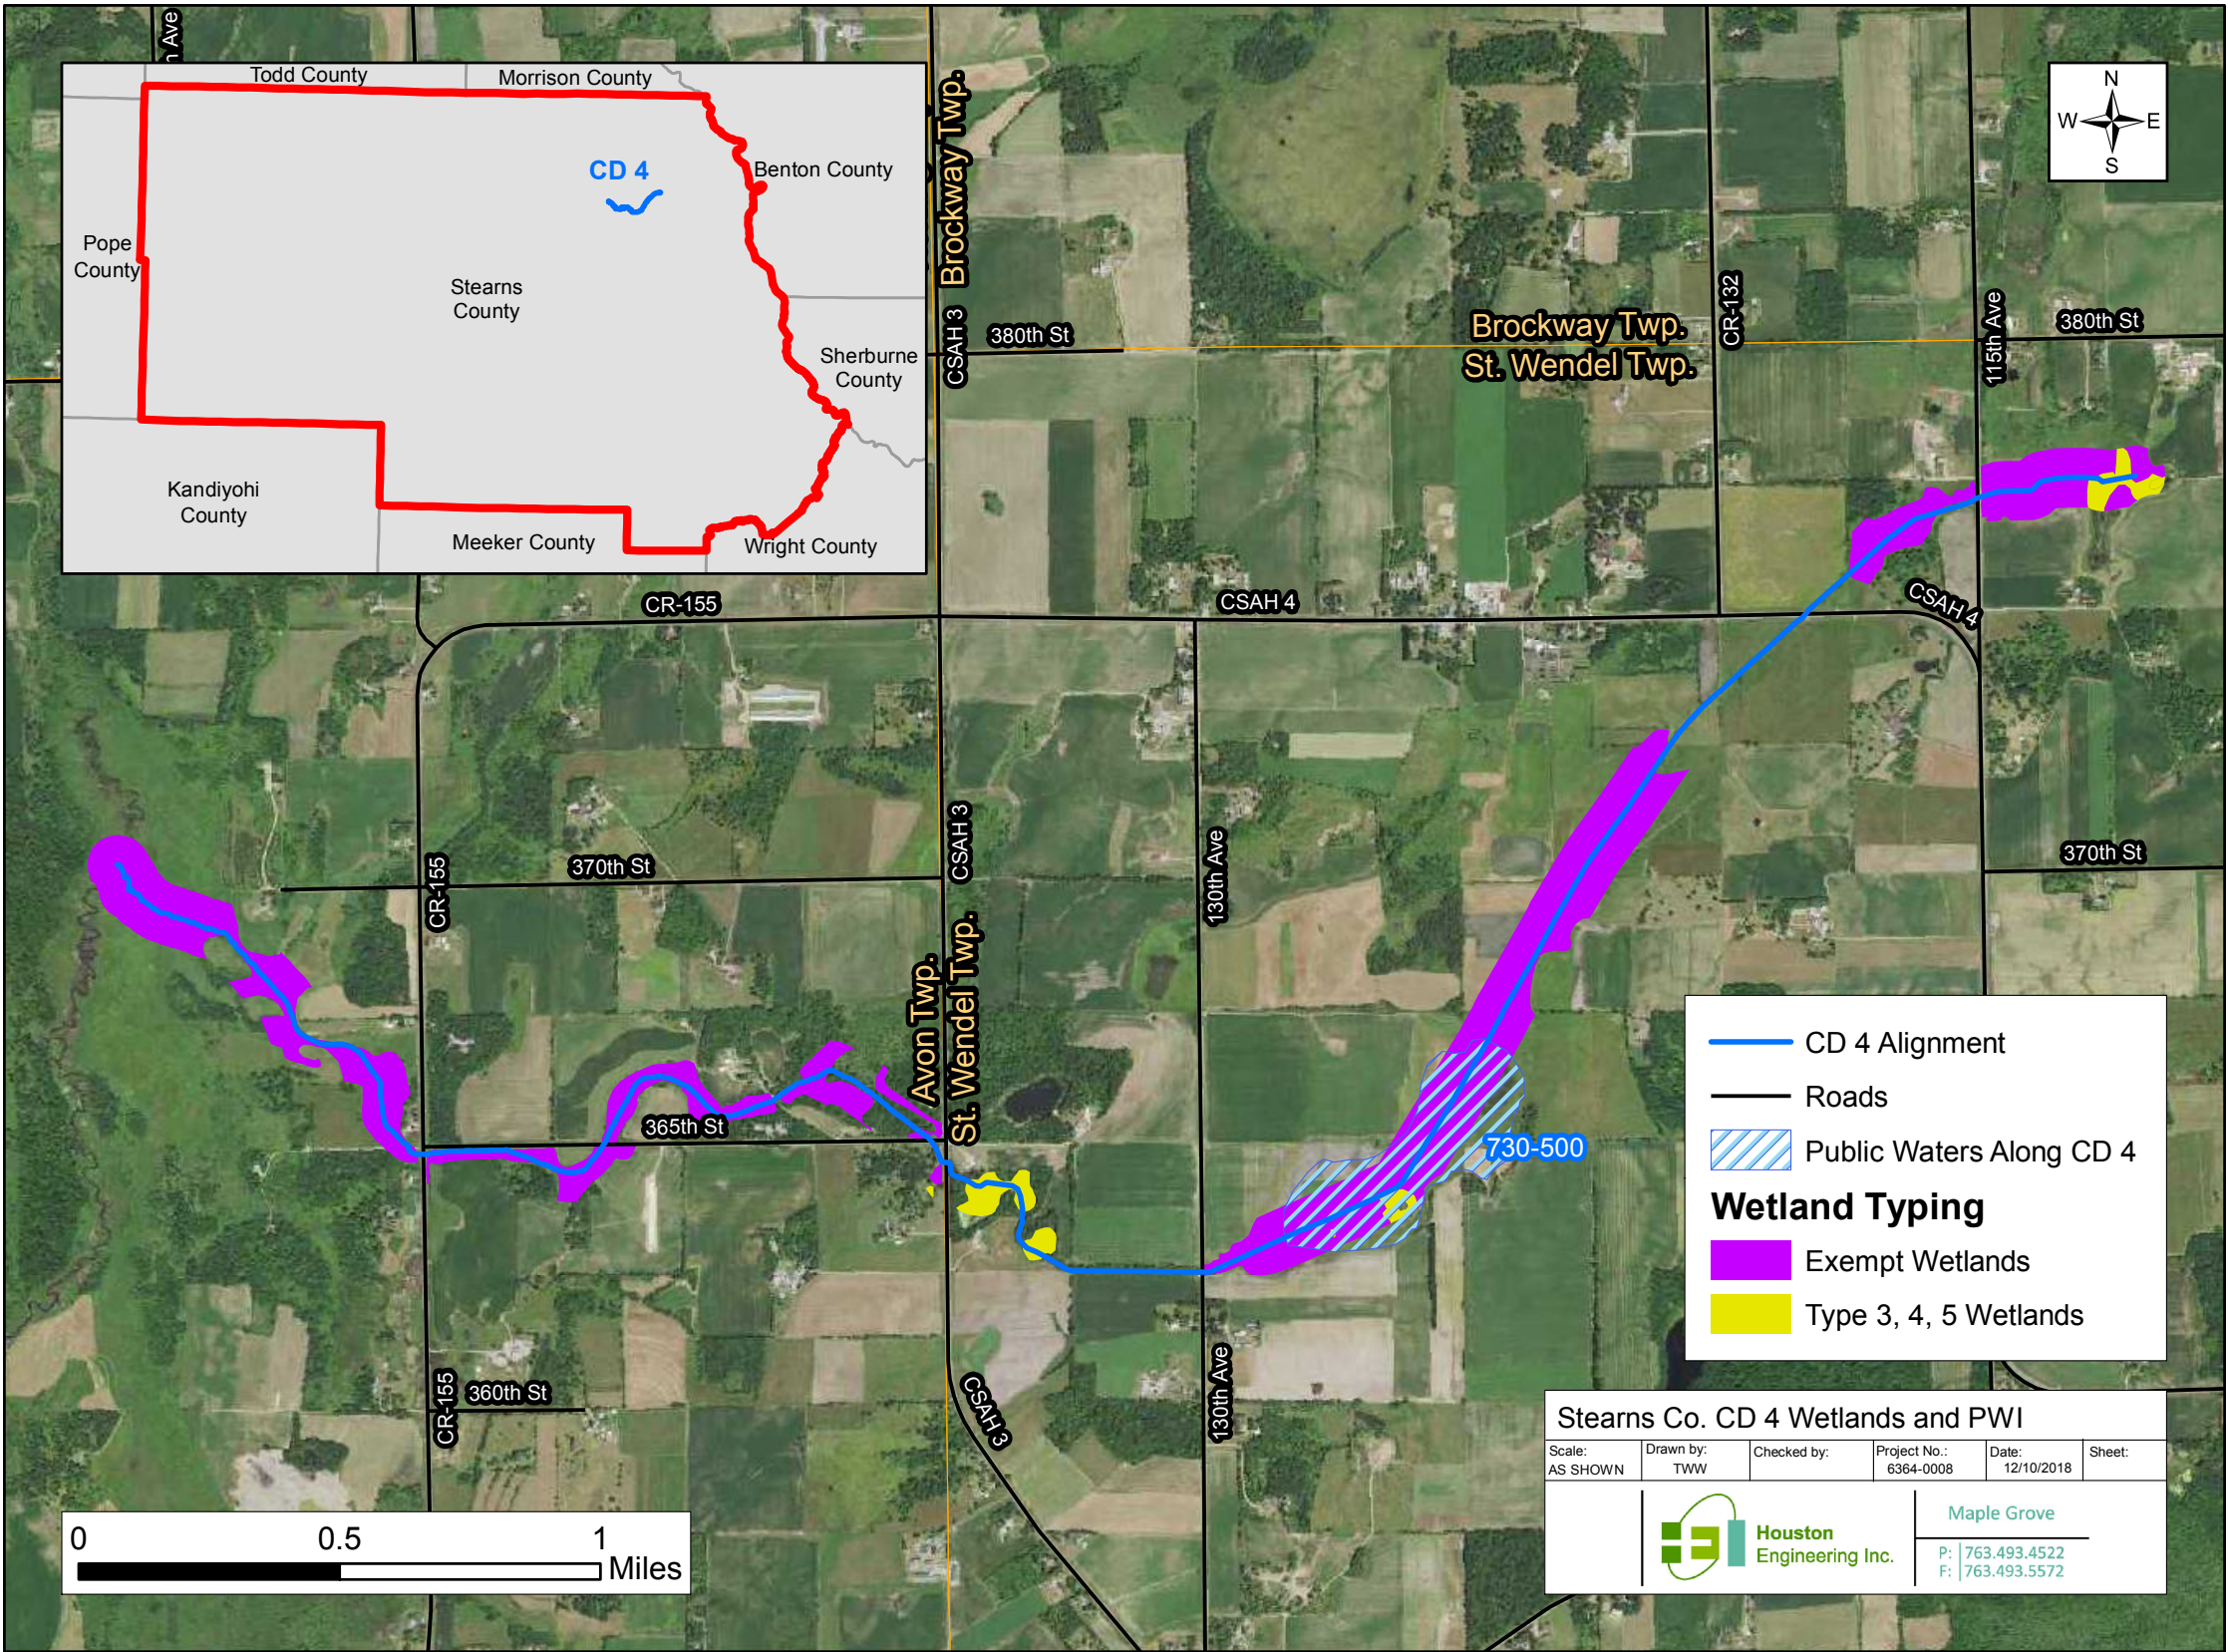
**Stearns Co. CD 4 Wetlands and PWI**

As seen in **Figure 1**, the CD 4 public drainage system contains one MnDNR listed Public Water (Unnamed Public Water Wetland #73-050W). Drainage system activities within Public Waters (below the OHW elevation) may require a permit or permissions from the DNR. The Minnesota DNR

regulates work within public waters, and generally exempts public drainage repair from a public waters work permit if they are located within an altered natural watercourse or do not substantially affect public waters. However, it appears that this Public Water may not meet the criteria of a public water listing, which is generally Type 3, 4 and 5 wetlands that are 10 or more acres in size. Based on our review of aerial photography, this PW is routinely cultivated, indicating that it more closely meets the criteria of a Type 1 or Type 2 wetland. There are no indications from aerial photography that this wetland is a Type 3, 4 or 5 wetland now or at the time of its classification as a public water (late 1970s). Therefore, this wetland was improperly classified as a public water, and we recommend Stearns County request the MnDNR to reclassify this wetland as a non-public water, in which case it would be regulated by state Wetland Conservation Act rather than Public Waters laws.

The CD 4 public drainage system runs through a series of wetland complexes, as seen in **Figure 3** Under most regulatory programs (i.e. Minnesota Wetland Conservation Act (WCA), Federal Clean Water Act (CWA); and Minnesota Public Waters Law) activities related to repair of a public drainage system, though potentially taking place within wetlands, are generally exempt from regulation, including mitigation requirements. These activities related to public drainage system maintenance and / or repair include:

Because the CD 4 public drainage system intersects several Type 3, 4 and 5 wetlands, modifications to the public drainage system grade may require a permit application with a replacement plan or an application for a no-loss determination. Further review, including a field observation, is recommended before drainage system repairs are completed.

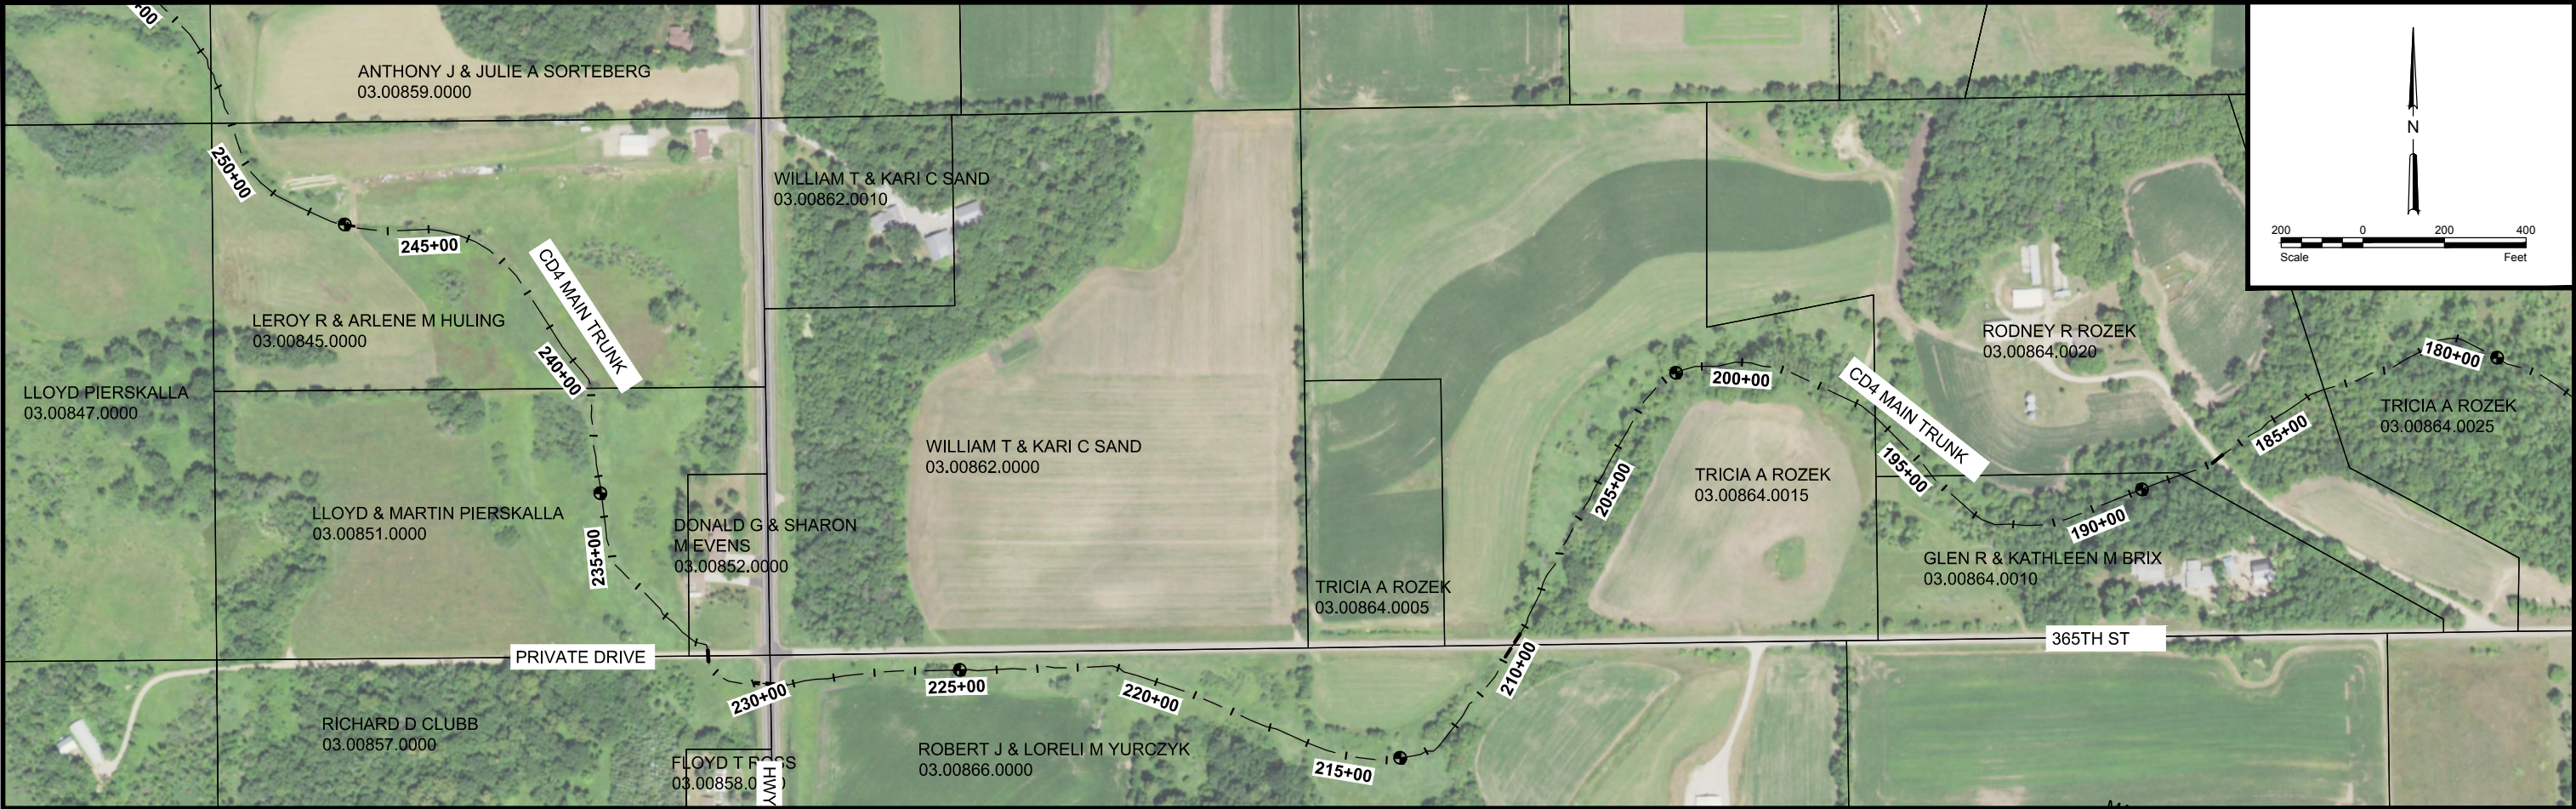
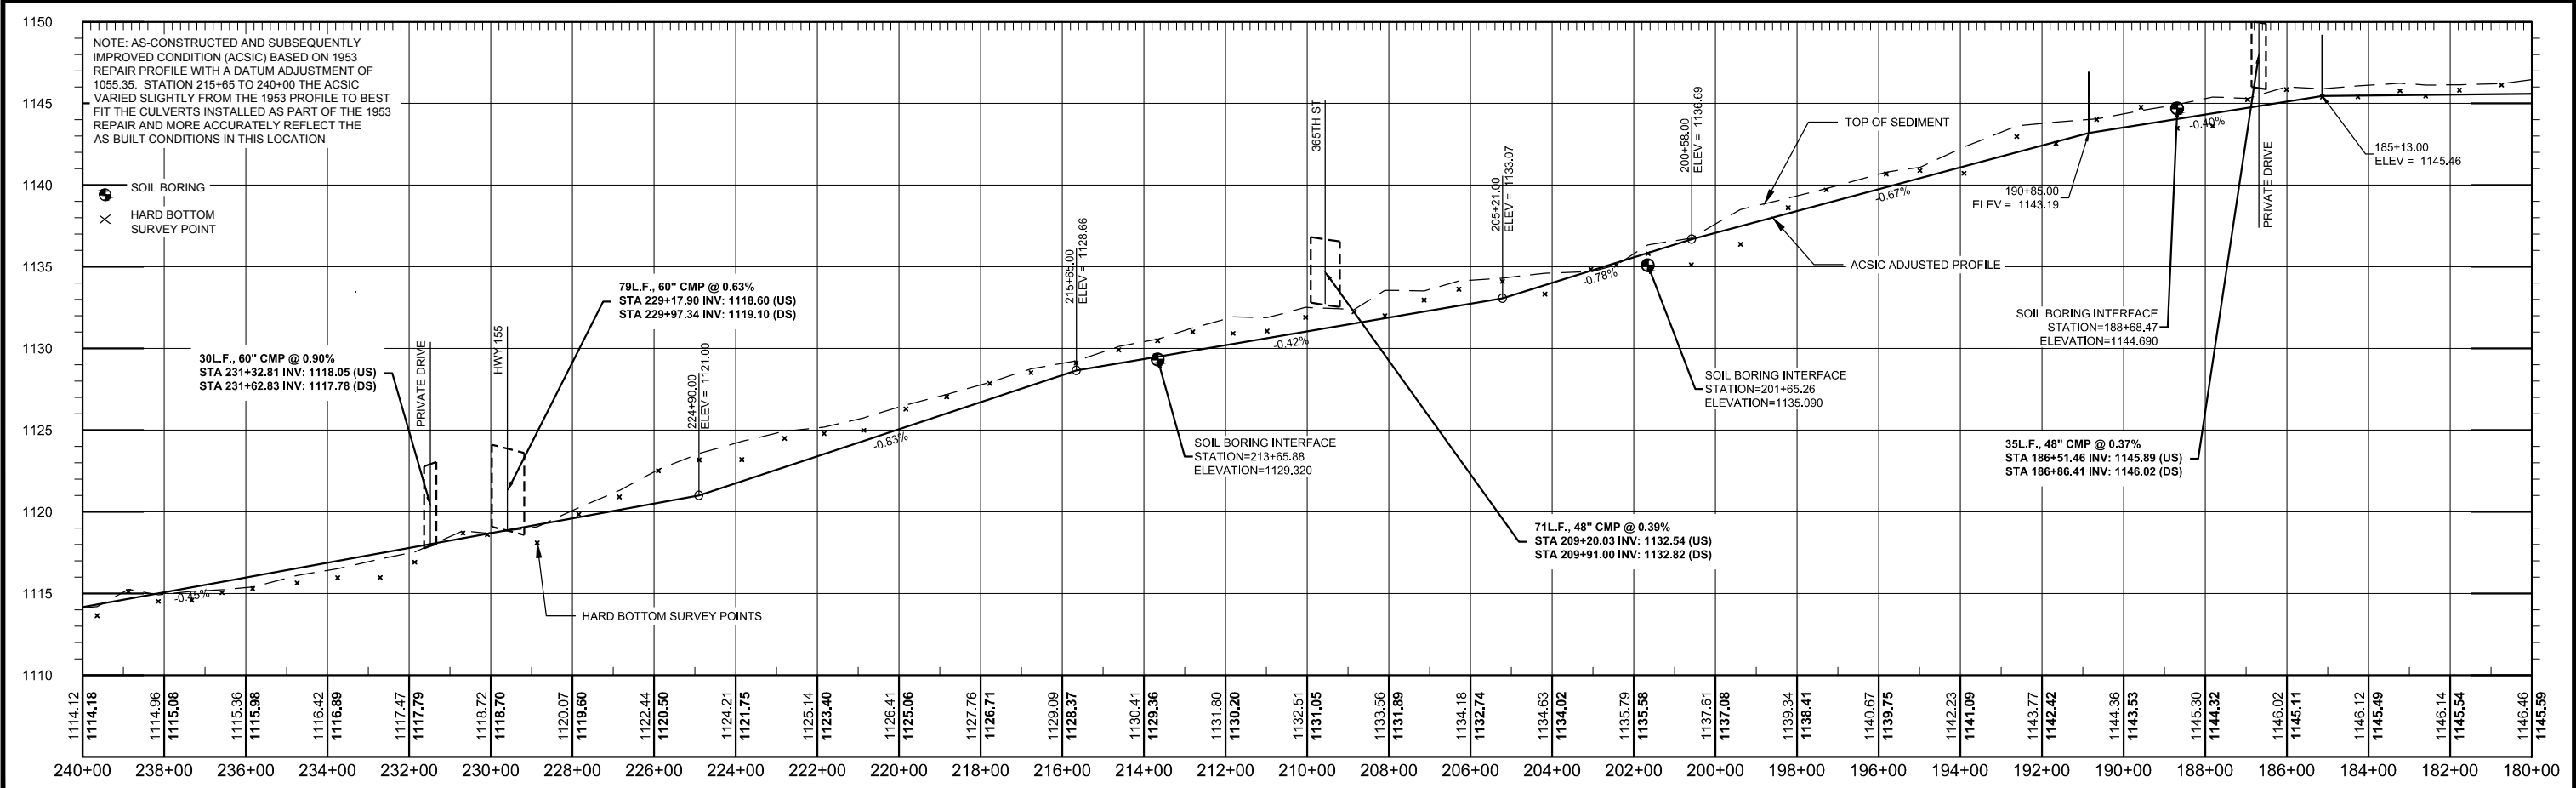
There are two locations where the proposed ACSIC varies from the 1953 repair profile. These are from STA 215+62 to 240+00 and downstream of STA 249+02. From STA 215+62 to 240+00 the proposed ACSIC was altered from the 1953 to simplify the number of grade breaks and reflect the as constructed elevation by drawing a "best fit" line that is supported by the hard bottom survey and culverts included in the 1953 repair and does not vary significantly from the surrounding ACSIC. This change is not expected to result in a reduction of original drainage capacity. Downstream of STA 249+02, the drainage system starts approximating a more natural channel. In this location, the 1953 repair profile is much lower than the hard bottom survey and neighboring soil borings. Therefore, a "best fit" line was again drawn that was supported by the hard bottom survey and soil borings and best represents the as-constructed condition.
