## Technical Memorandum

**Subject:** Stearns County Ditch 28 Conditions Report

**Date:** June 3, 2020

**Project:** R006364-0010.004

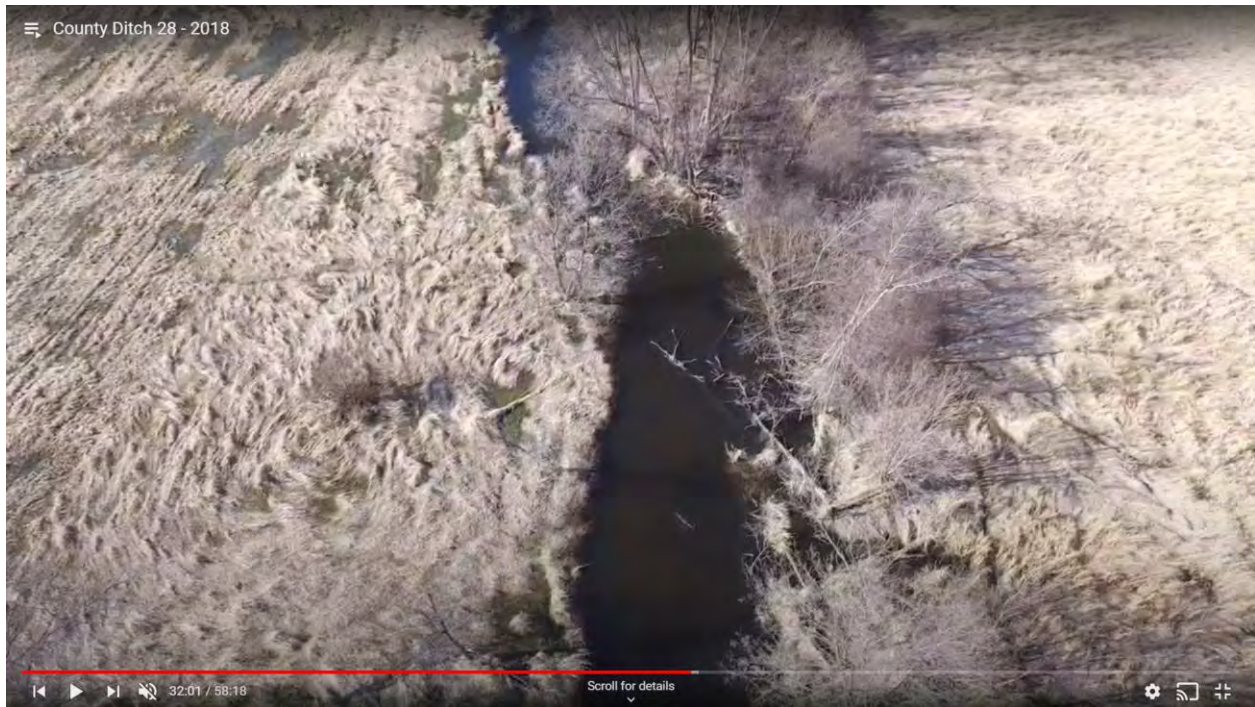
**Photo 1: Deadfalls in ditch**

HEI completed a review of the UASs video captured by the Sheriff's Department in 2018. Spread throughout the CD 28 system are several dead or dying trees that partially block the channel (**Photo 1**). There are also reaches of dense tree cover immediately adjacent to the channel that diminish access for maintenance activities and are

Subsequent to the removal of the fish barrier, we recommend that the County pursue the completion of a Repair Report for the CD 28 public drainage system consistent with the ACSIC pursuant to MN Statute 103E. Stearns County Ditch 28 (CD 28) is in disrepair downstream of Two Rivers Lake. The hydraulic assessment shows that repairing the CD 28 channel will result in a reduction in flooding around Two Rivers Lake, and along the CD 28 channel. This reduction is most significant for the 2-year event along the CD 28 channel, and for the 10- and 100-year events at Two Rivers Lake. The Repair Report, which would include a detailed survey of at-risk structures, will further evaluate repair options. In most cases, repairs would consist of excavating accumulated sediment from the channel bottom and removal of trees located within and adjacent to the channel. Furthermore, the County may wish to evaluate a phased approach to address key areas within the scope of the repair report. However, note that phasing the repair may result in an overall increase in project cost, as it will require multiple mobilizations of equipment and will not take advantage of an economy of scale.

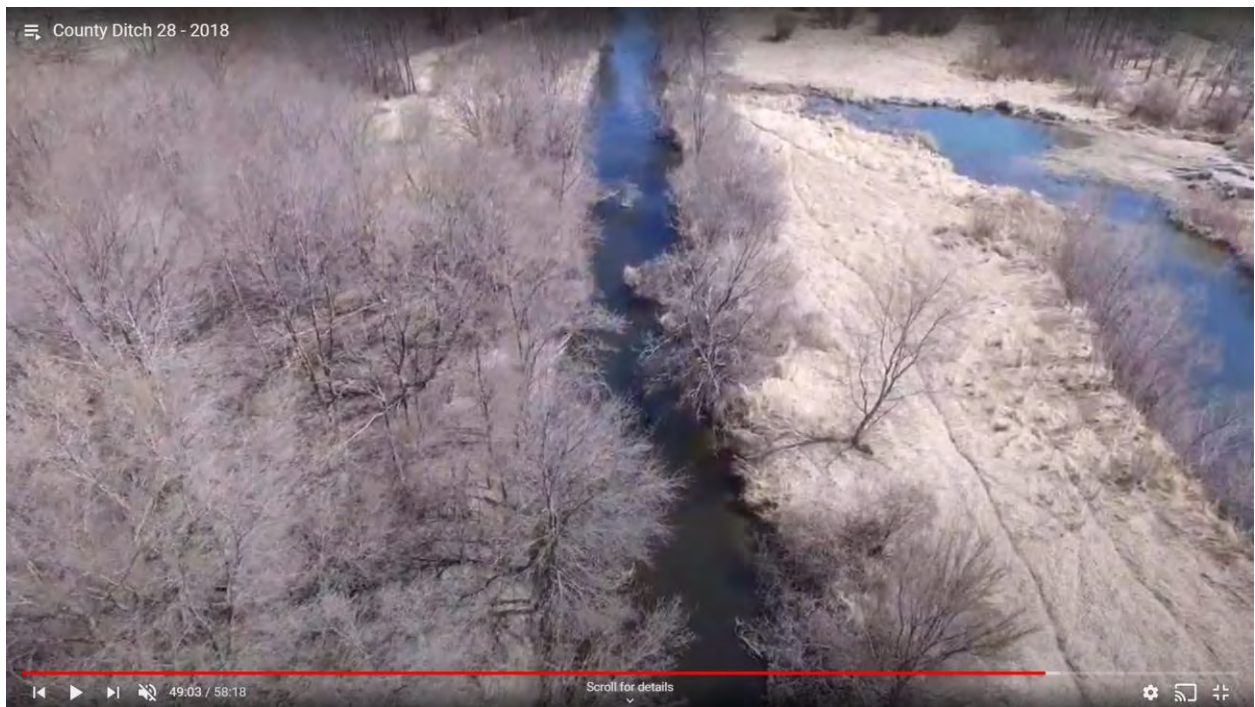
**Photo 2: Trees along the ditch**

likely to eventually fall into the channel and become blockages (**Photo 2**). Though assessing the efficiency of the channel bottom is unclear from UAS video, the channel bottom upstream of Two Rivers Lake appears to be an undulating bottom with several areas where sediment is near or at the surface of the channel. Downstream of Two Rivers Lake, there is an obvious sediment delta at the confluence with Krain Creek.

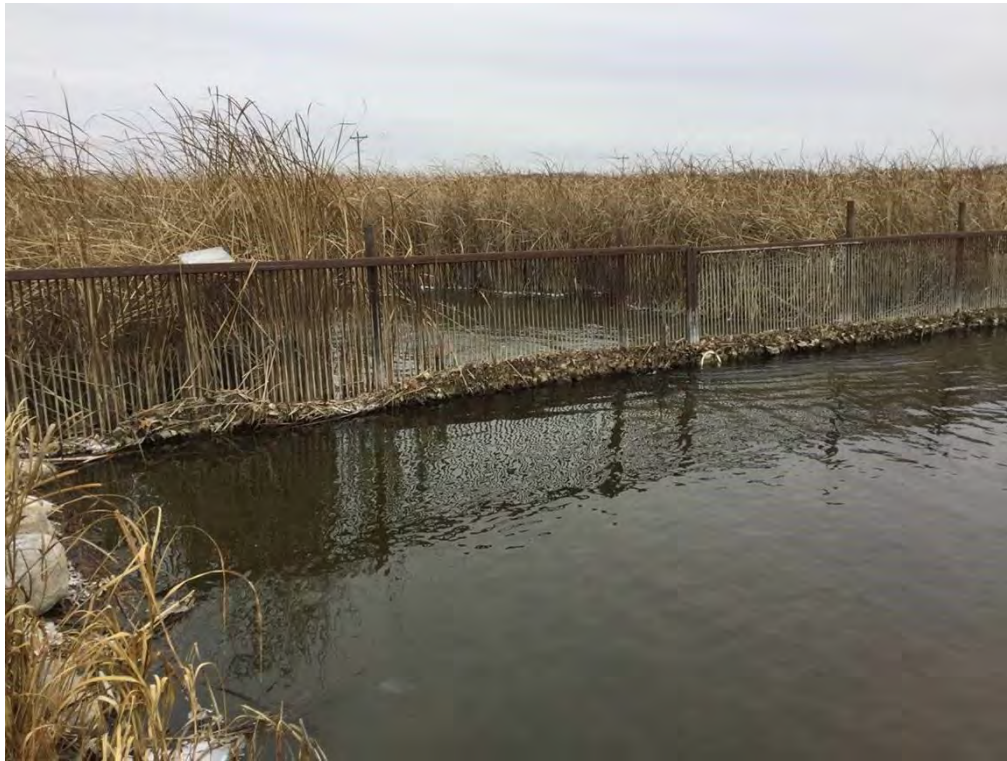
**Photo 3:** Fish barrier at the outlet of Two Rivers Lake.

The County also completed physical survey as part of the recent Record Reestablishment that was completed for CD 28. Observations on the channel profile were included in that report and include a note that there are areas of significant sediment accumulation in excess 3-feet downstream of Two Rivers Lake. Additionally, during the channel bottom survey, County survey staff observed the carp trap at the outlet of Two Rivers Lake to be plugged with vegetation (see **Photos 3, 4, and 5**).

We recommend that the fish barrier at the outlet of Two Rivers Lake be removed immediately, as the barrier is an unauthorized obstruction to the public drainage system. Removal of the barrier is expected to realize most of the available reduction in peak water surface elevation amongst the options evaluated in this report. Additionally,

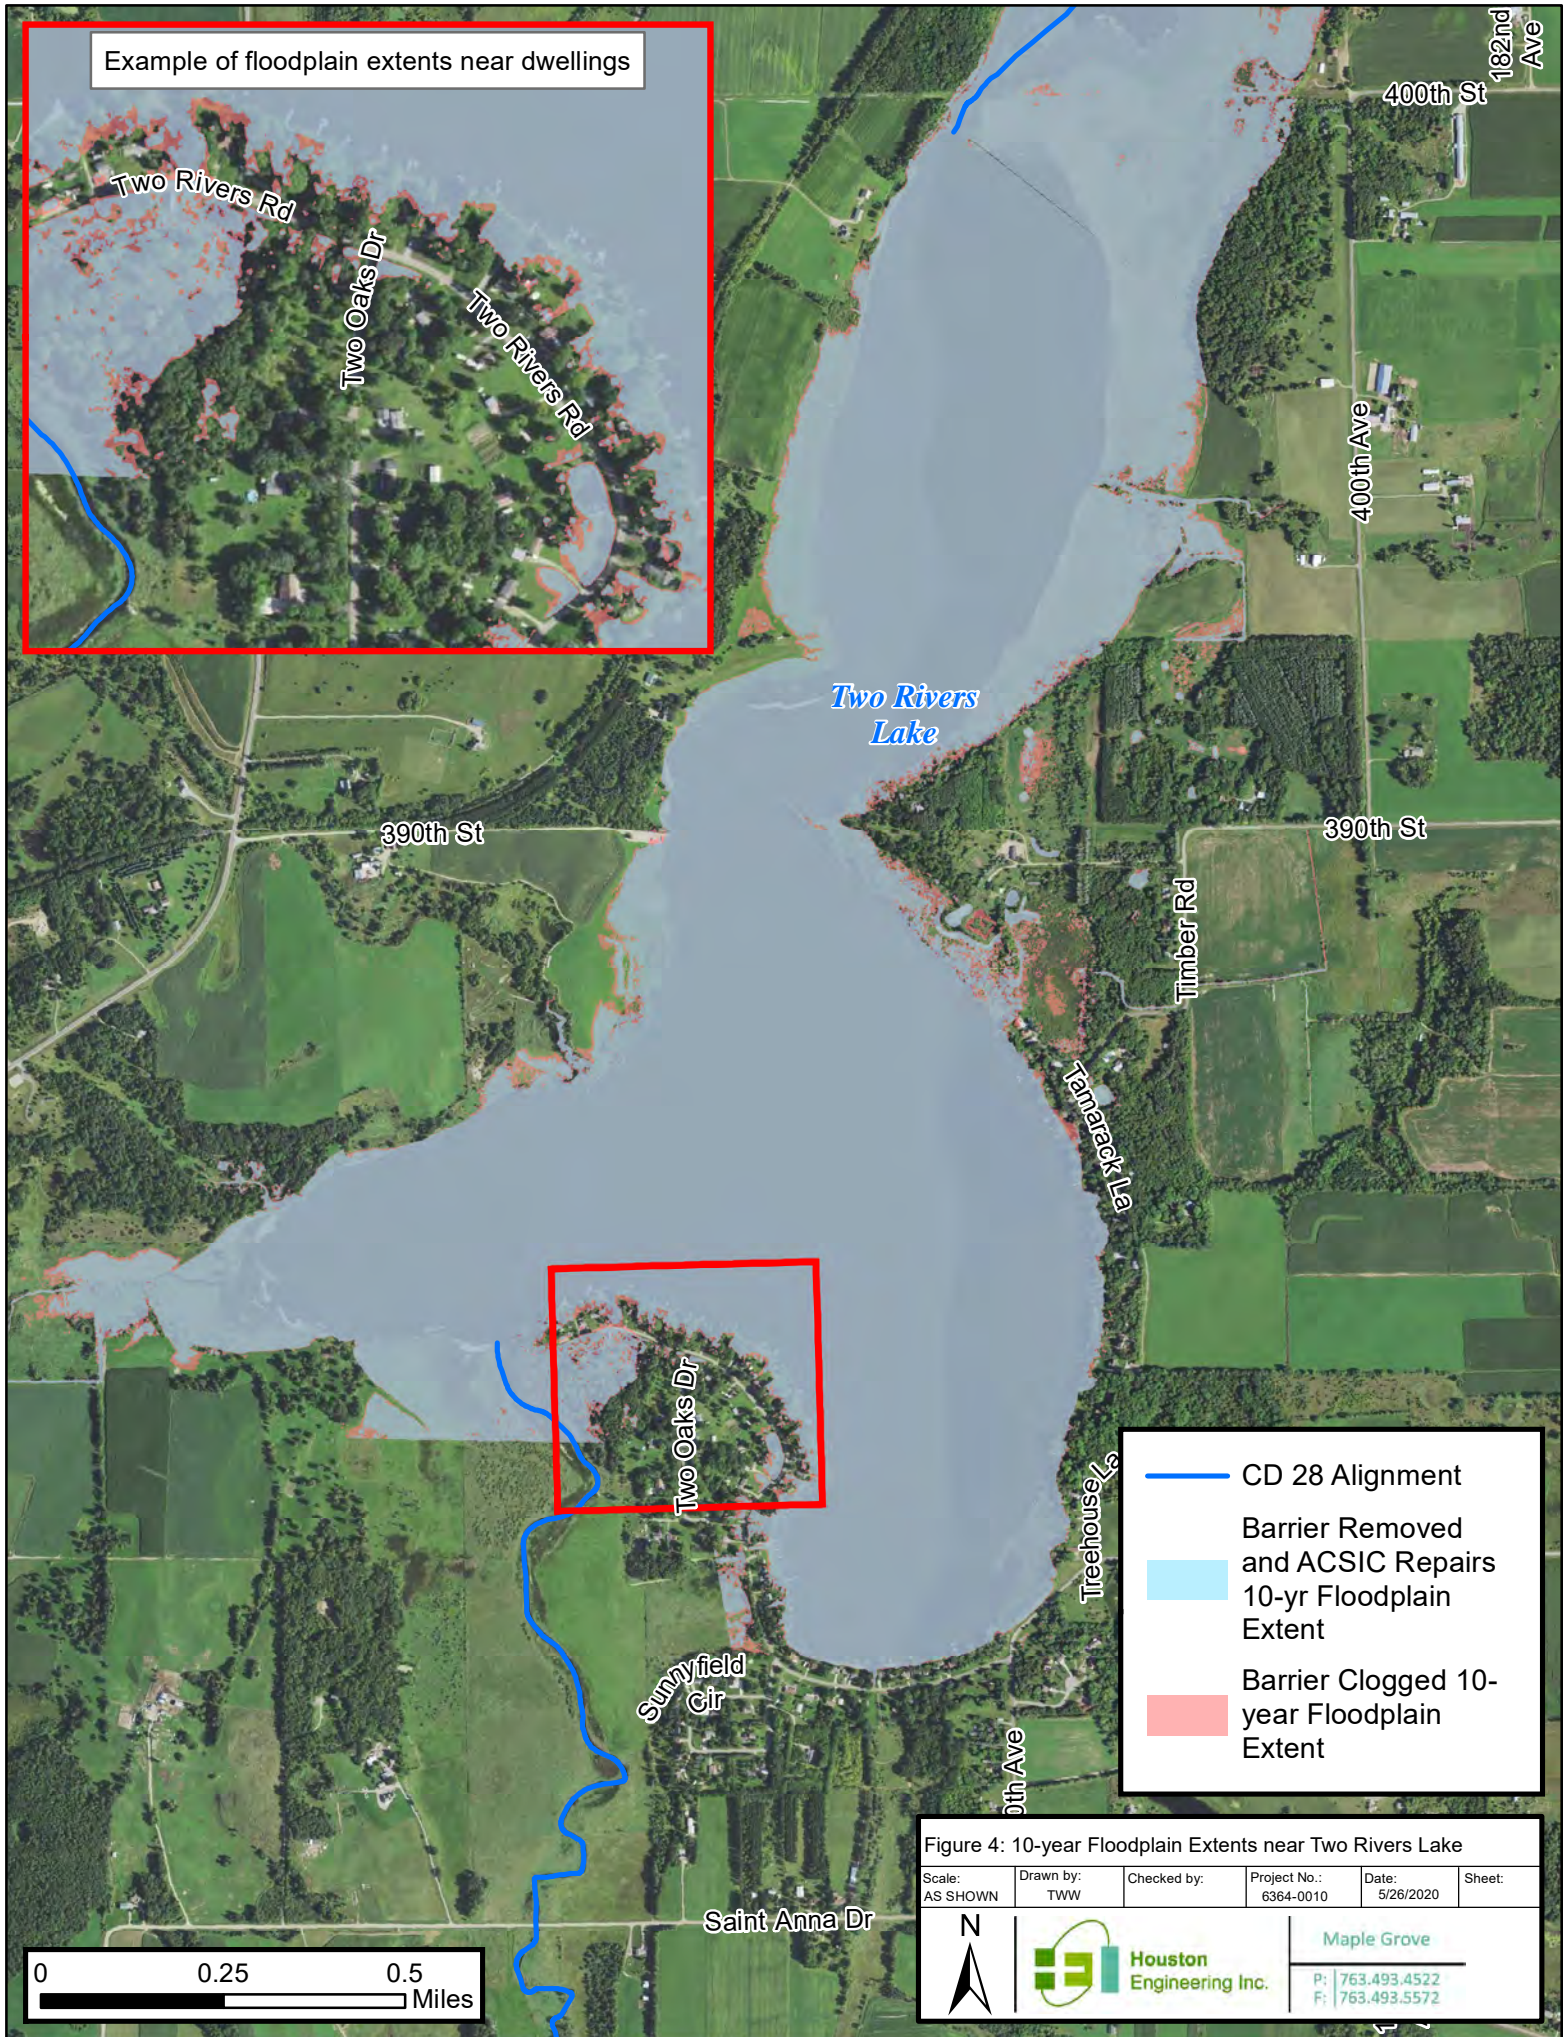
Figure 4: 10-year Floodplain Extents near Two Rivers Lake

The 10-year and 100-year events also show reductions in maximum flood elevation at Two Rivers Lake as shown in **Table 1**. The floodplain extents in upland areas along the lake for these events will continue to be substantial due to the volume of water passing through Two Rivers Lake. The floodplain extent for the current condition and the condition with barrier removal and ACSIC channel repairs for the 10-year rainfall event is shown in **Figures 4 and 5**, and the 100-year event in **Figures 6 and 7**.

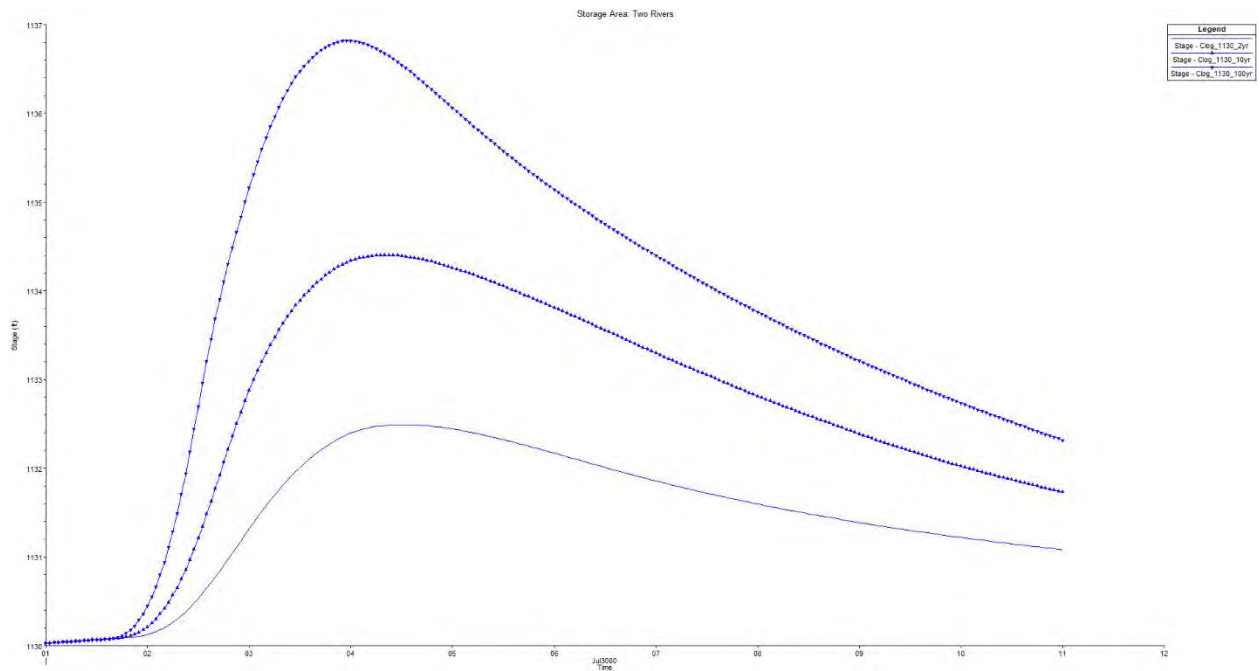
**Figure A-2:** Two Rivers Lake elevation vs time for Scenario 1 for the 2-year, 10-year, and 100-year events.

Scenario 1 is the current condition, with a 100% clogged fish barrier to an elevation of 1130 (NAVD '88) at lake outlet and with no channel repairs to CD 28. The fish barrier was modeled as a weir at the elevation of 1130. This was based off the 2018 topographic survey. A normal water level of 1130 was also used at the start of the model run. A plot of Two Rivers Lake elevation vs time for Scenario 1 can be seen in **Figure A-2**.

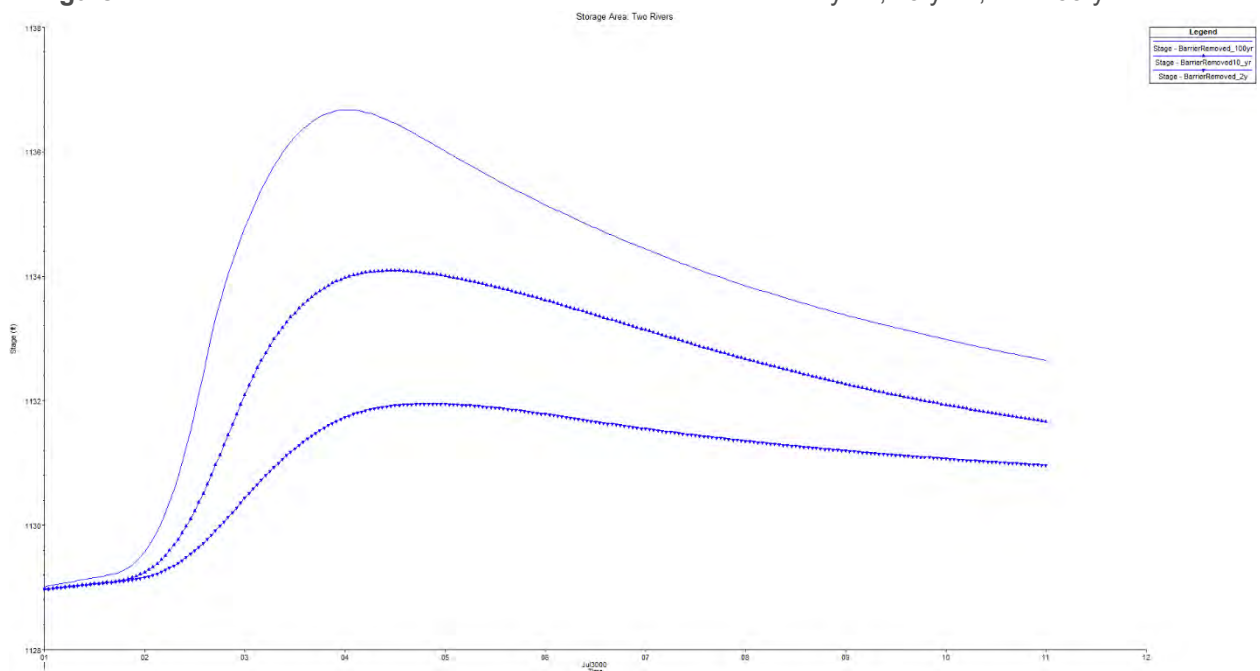
**Figure A-3:** Two Rivers Lake elevation vs time for Scenario 2 for the 2-year, 10-year, and 100-year events.

Scenario 2 includes removal of the fish barrier but no channel repairs to CD 28. The weir representing the fish barrier was removed from the model so that the normal channel cross-section at the outlet of Two Rivers Lake was unaltered. A normal water level of 1127.8 was used at the start of the model run, assuming the normal water level was lowered by barrier removal but allowing it to rise to an appropriate elevation by the time the concentrated storm event reaches Two Rivers Lake. A plot of Two Rivers Lake elevation vs time for Scenario 2 can be seen in **Figure A-3**.

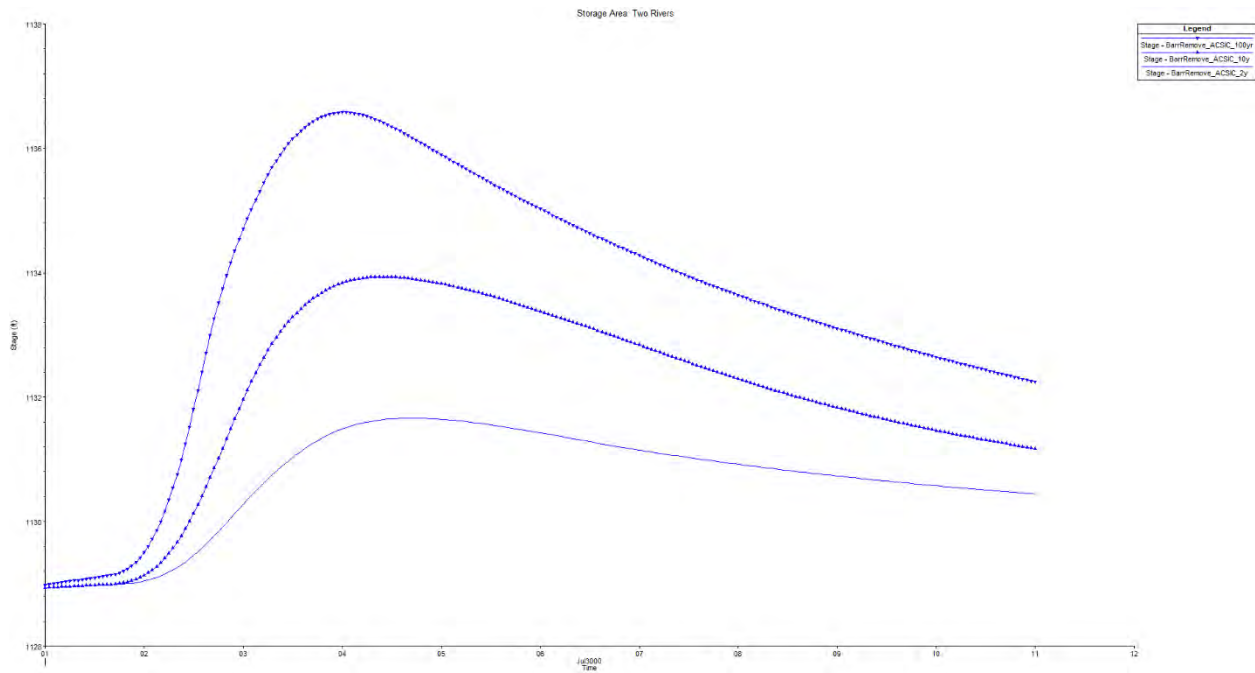
**Figure A-4:** Two Rivers Lake elevation vs time for Scenario 3 for the 2-year, 10-year, and 100-year events.

Scenario 3 includes removal of the fish barrier and repair of CD 28 to the As Constructed and Subsequently Improved Condition (ACSIC) downstream of Two Rivers Lake. The channel cross-sections in the HEC-RAS model were edited to the ACSIC condition. The ACSIC channel condition with a 10-foot bottom width and 1:1 side slopes was used to lower the current HEC-RAS cross-sections to the ACSIC elevation, given in **Appendix**

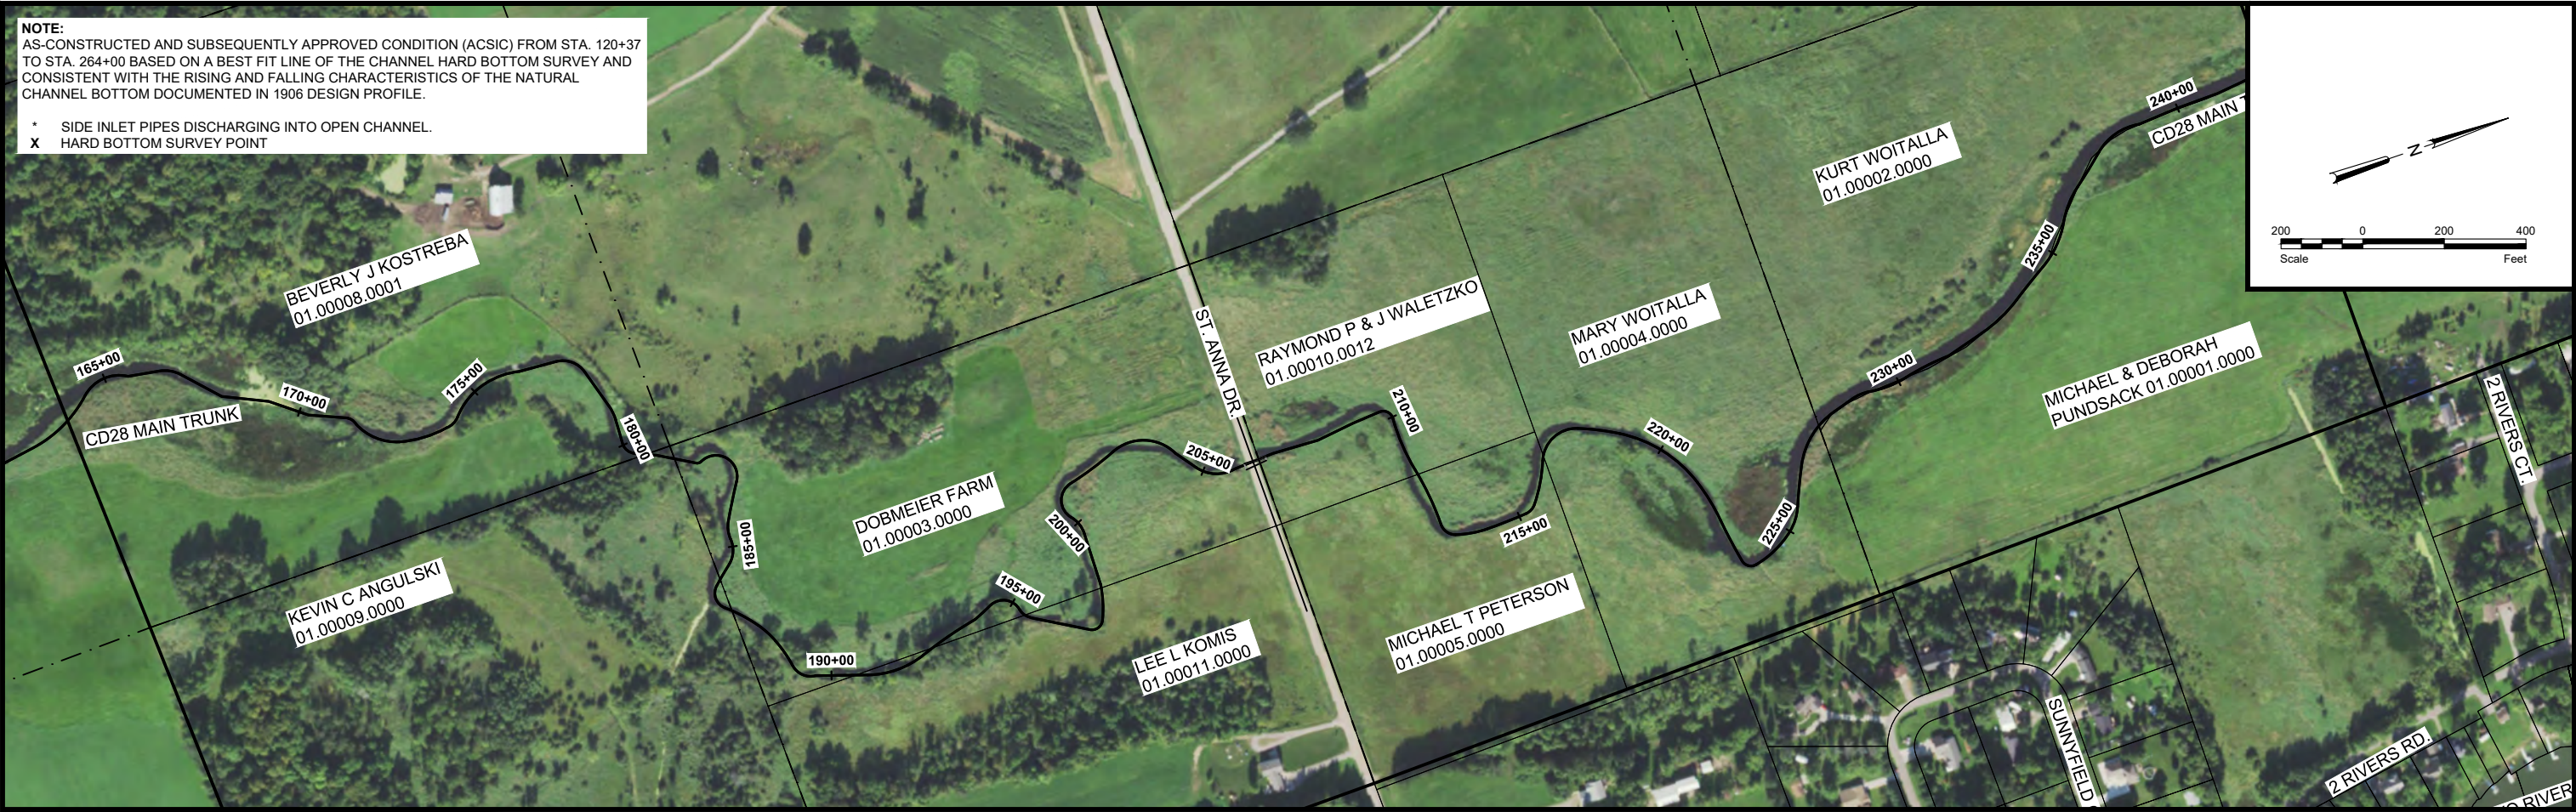
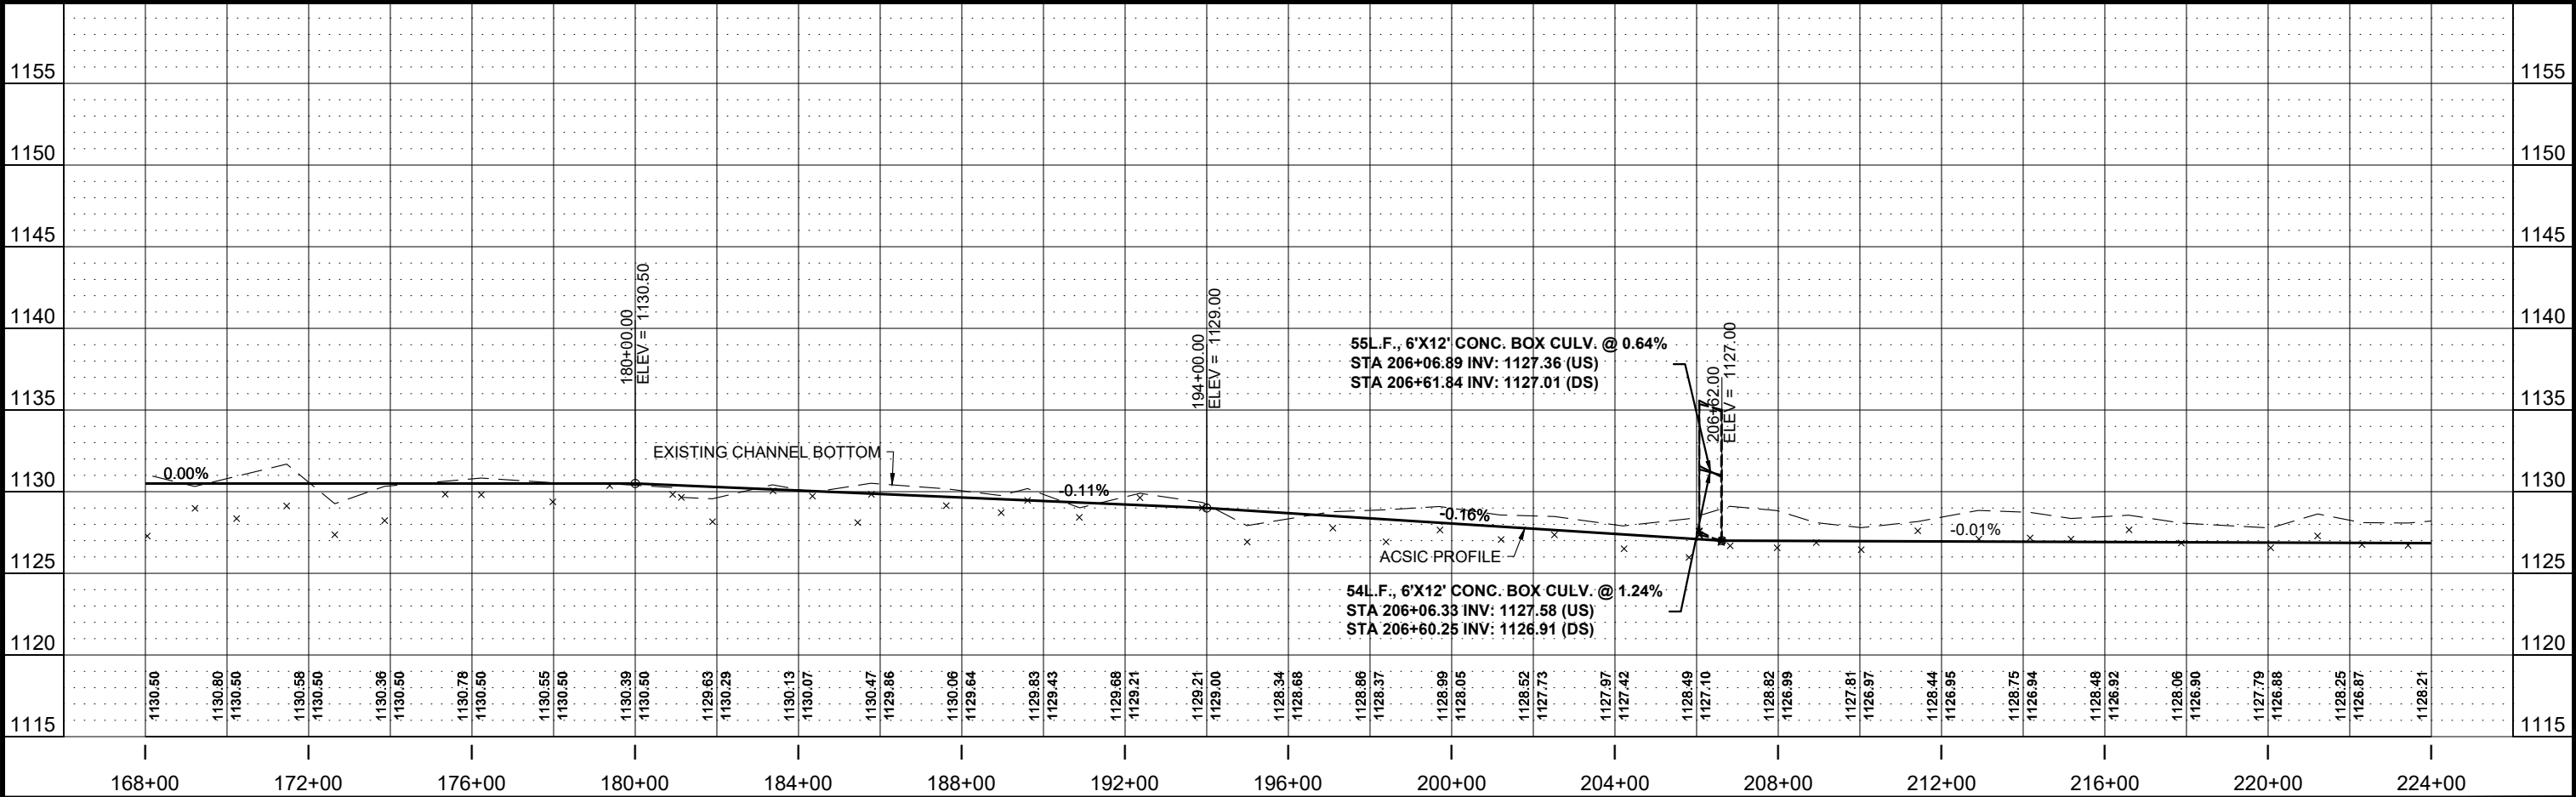
NOTE:  
AS-CONSTRUCTED AND SUBSEQUENTLY APPROVED CONDITION (ACSIC) FROM STA. 120+37 TO STA. 264+00 BASED ON A BEST FIT LINE OF THE CHANNEL HARD BOTTOM SURVEY AND CONSISTENT WITH THE RISING AND FALLING CHARACTERISTICS OF THE NATURAL CHANNEL BOTTOM DOCUMENTED IN 1906 DESIGN PROFILE.

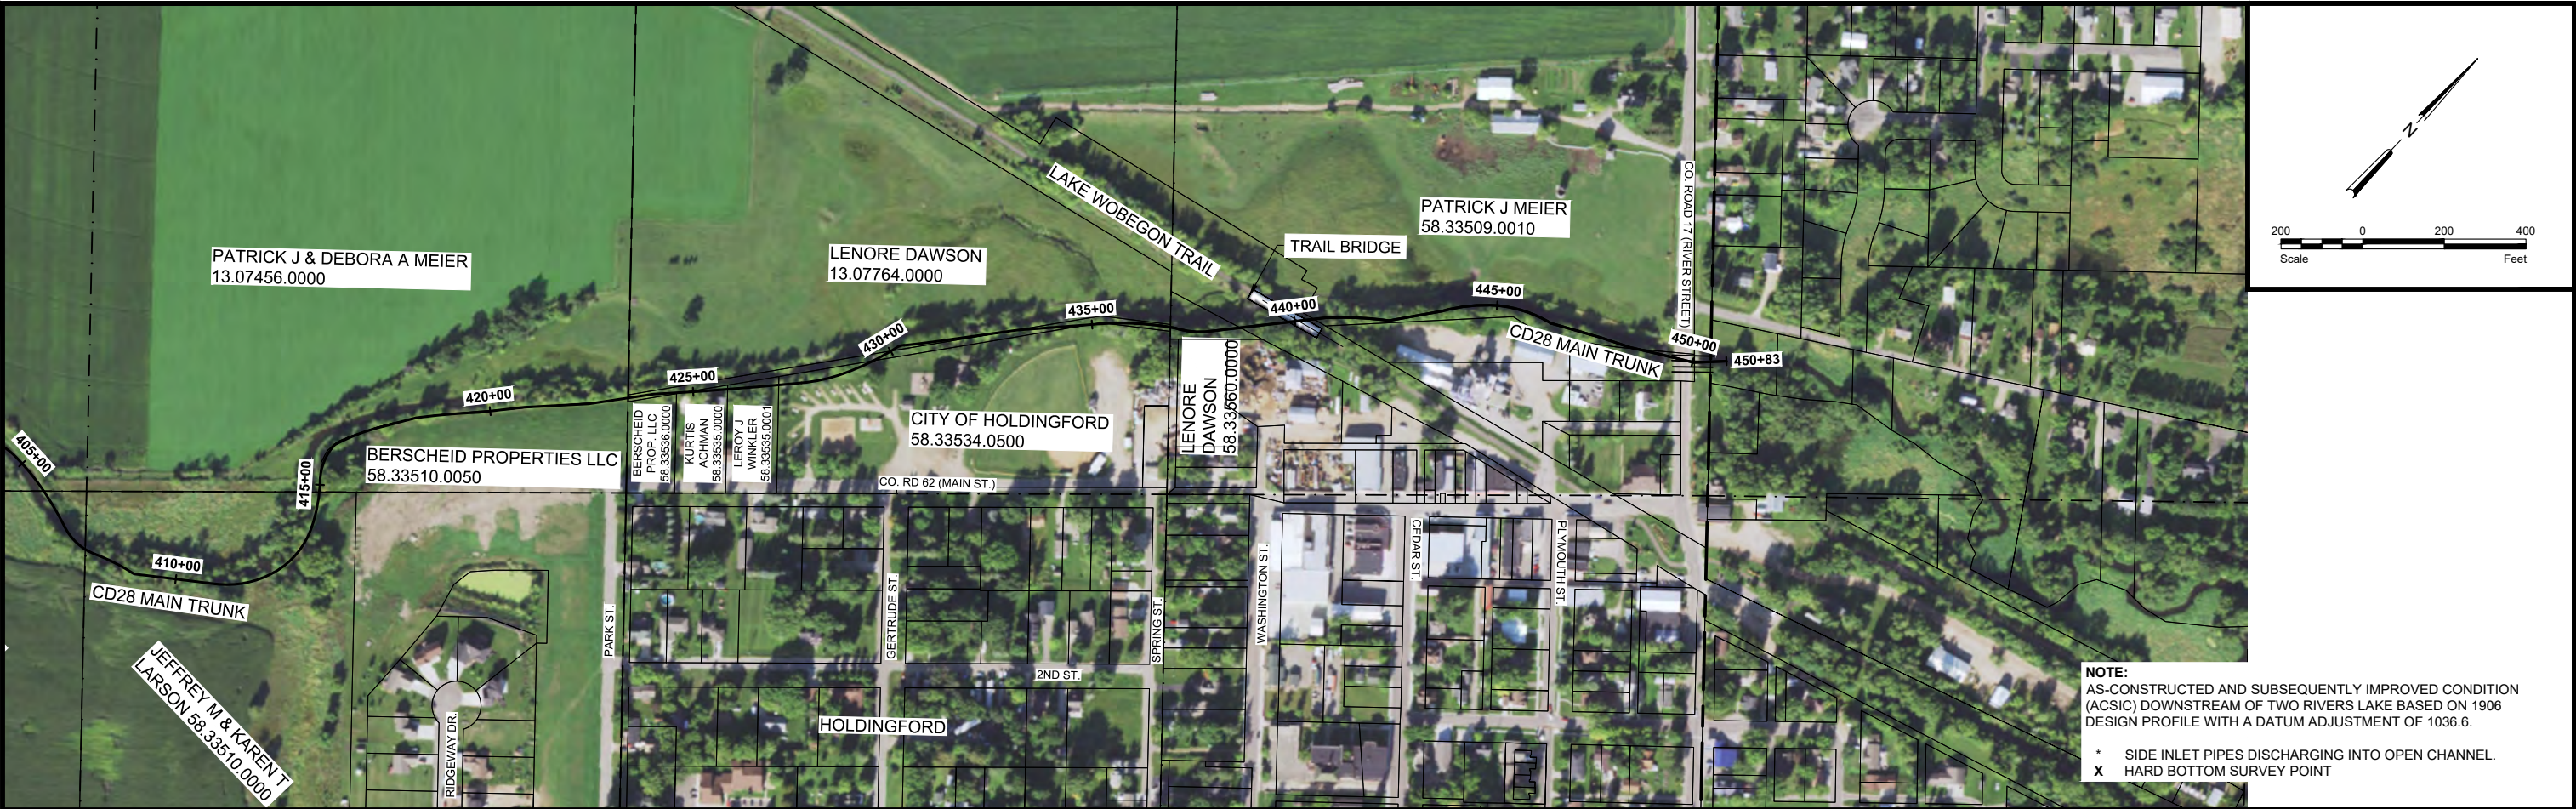
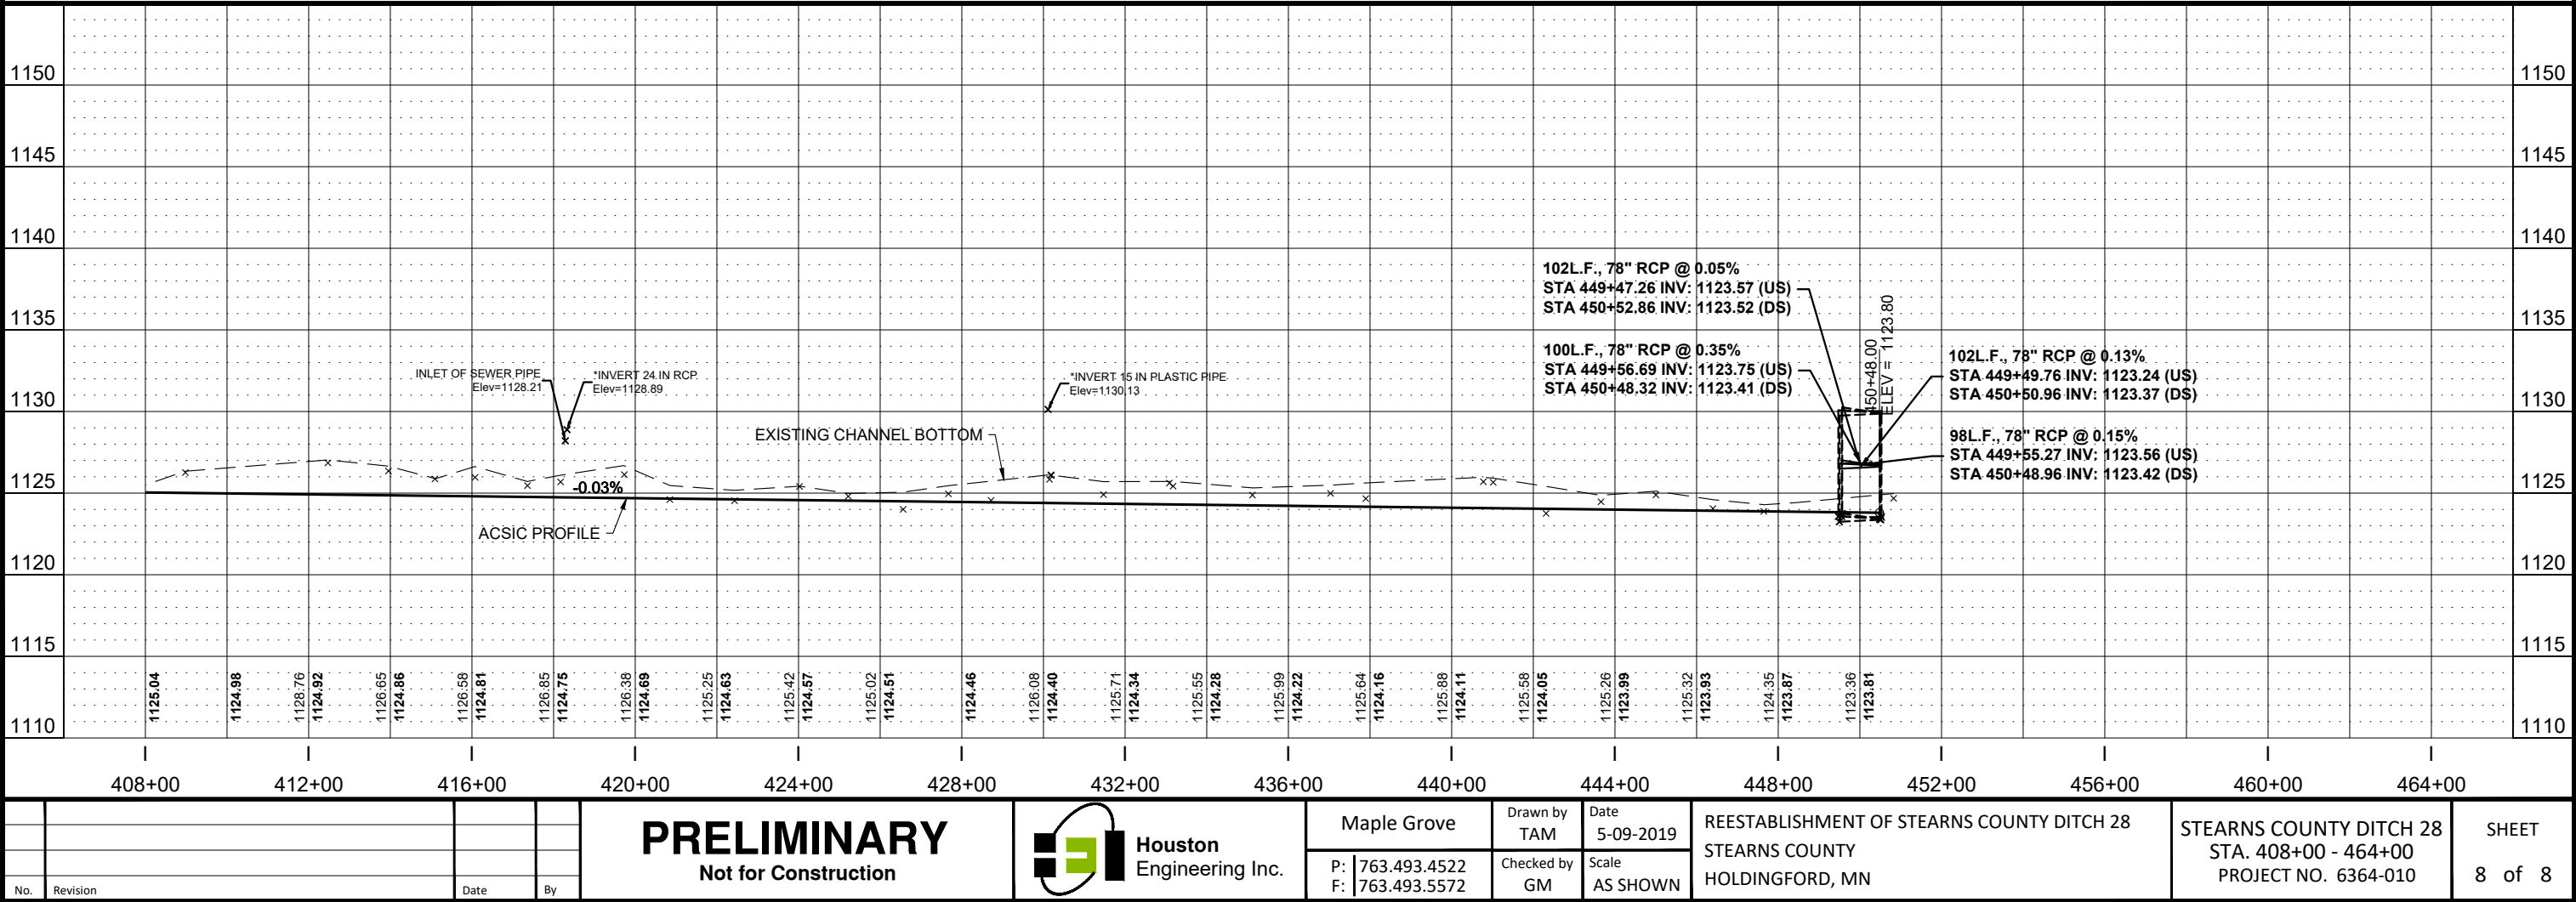
**NOTE:**  
AS-CONSTRUCTED AND SUBSEQUENTLY IMPROVED CONDITION (ACSIC) DOWNSTREAM OF TWO RIVERS LAKE BASED ON 1906 DESIGN PROFILE WITH A DATUM ADJUSTMENT OF 1036.6.
